The Church of Scotland  
**BISHOPTON PARISH CHURCH**  
Erskine Ferry Road, Bishopton, PA7 5PP

## **Masonry Conservation Project Phase 2**

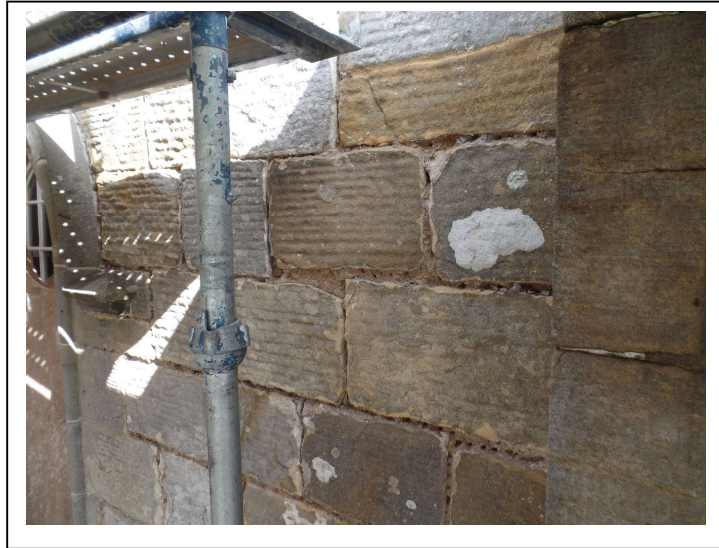
The OPC pointing has been removed to reveal the extent of and condition of the original lime mortar bedding in the Coursed Rubble masonry.

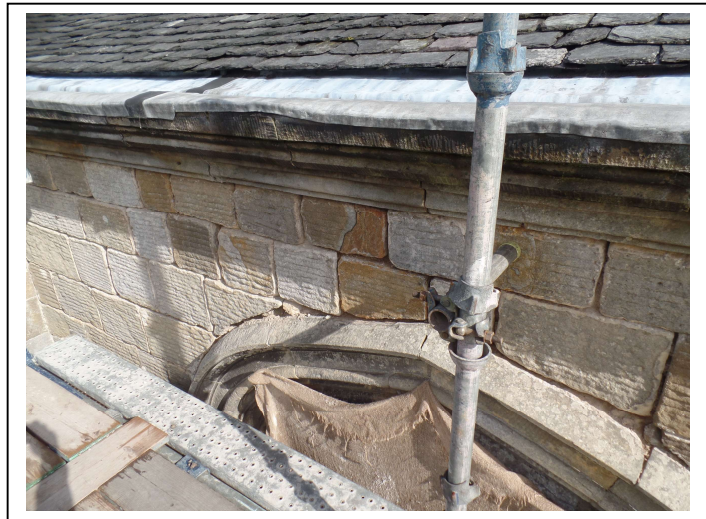
Coursed rubble at the South elevation wall head.

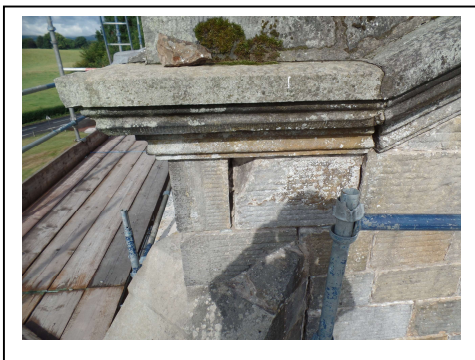
Coursed rubble and Ashlar at the East corner. Some damage has occurred to the stone while trying to get the OPC off!

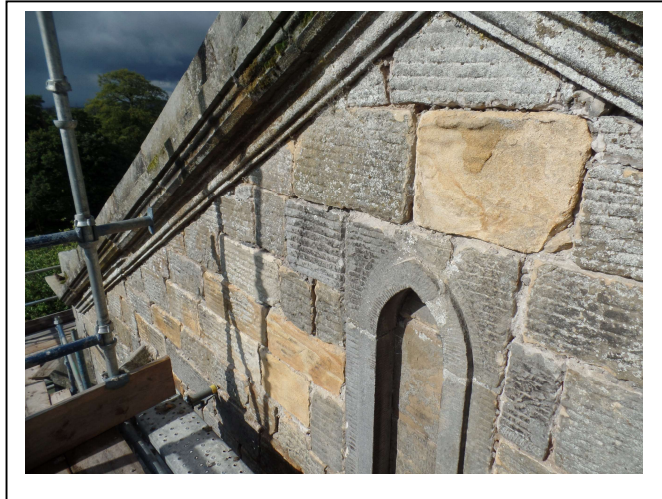
The East Gable, showing some “spalling” effects on the stone. This may be the result of softer stone but will not have been helped by the use of OPC pointing.

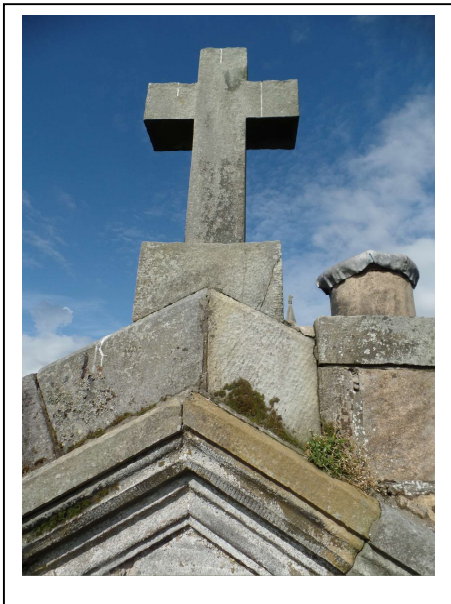
The Cross on the East Gable wall head. It had been thought that the “crack” on the RHS of the base may be loose, but it was found to be only a marking in the stone, and was quite sound. One less job to be done!

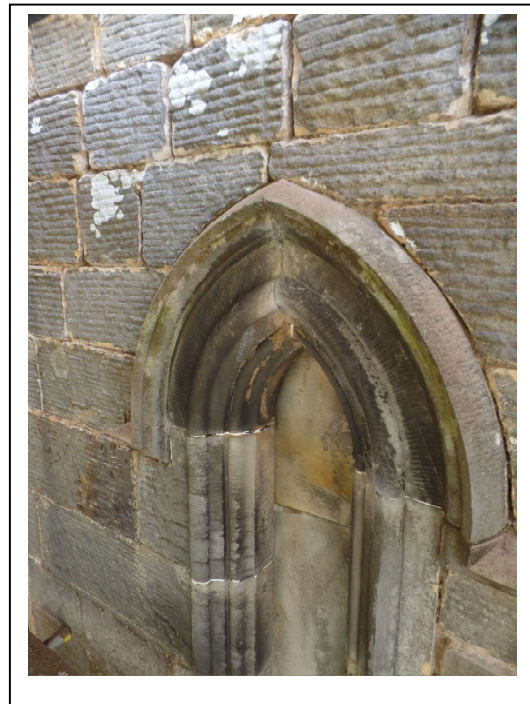
The West Gable. No real issues identified here other than a loose section of Ashlar dressing at the top of the buttress.

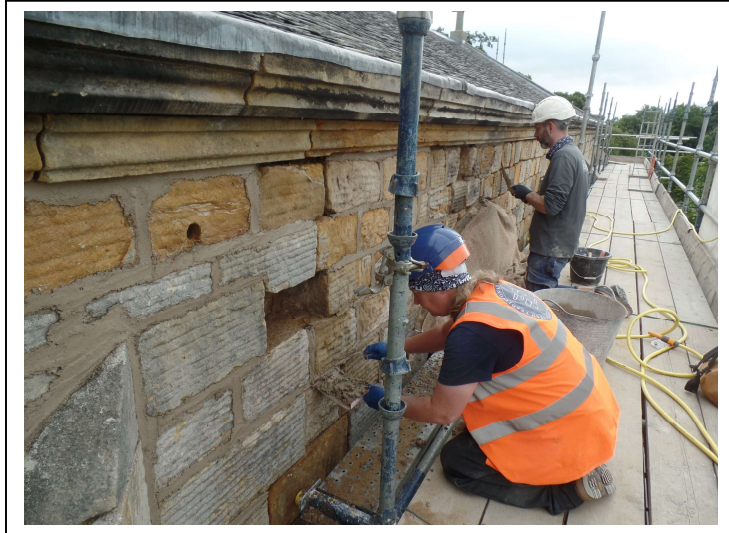
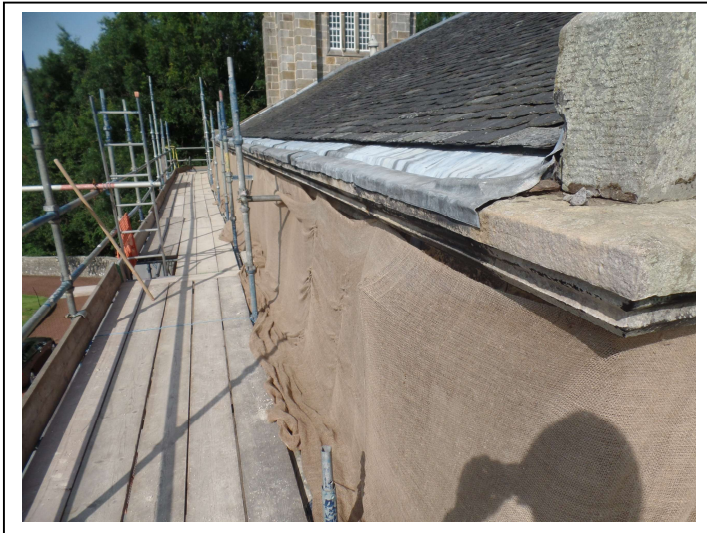
Packing and pointing with lime mortar on the top lift. The Ashlar joints have also been opened up in preparation for repointing. One defective stone has been removed – note how the original stonemasons adjusted the level of the coursed rubble horizontal joints so that the courses aligned with the top of the buttress.

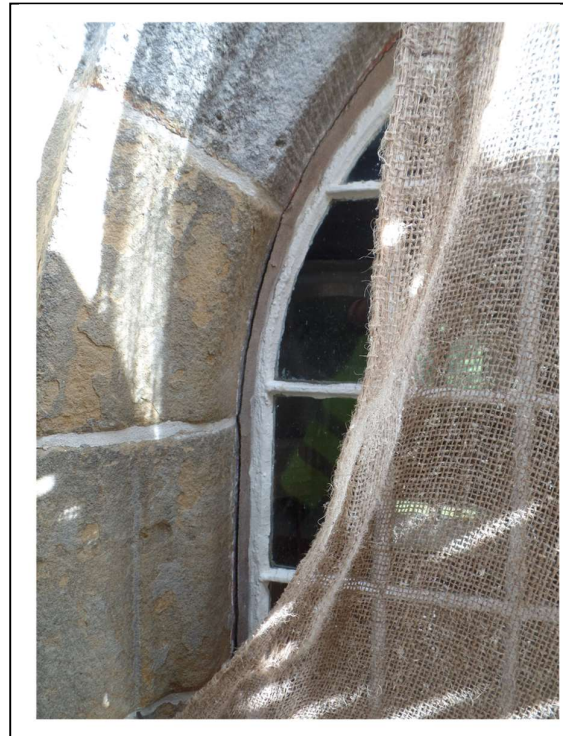
White lime mortar after being applied to one of the window mullions. Movement between the window frame and the surrounding stone has caused the Burnt Lime Mastic (around the window) to separate from the stone – this would be a rainwater ingress path and so has to be re-done.

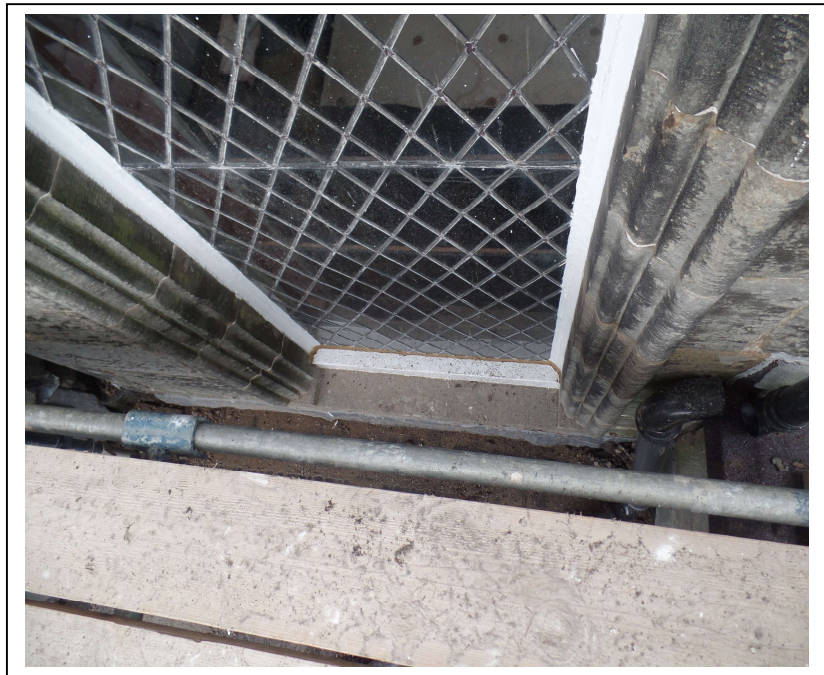
One of the East Gable windows. These were found to be in reasonable condition. There is however a need to properly repair one of the windows where the timber cill had failed and was letting rainwater into the Extension Hall. A temporary repair had already been made, so this work has been deferred until the final Phase of works, as it can be accessed comparatively easily from the Choir Room and Extension Hall roof.

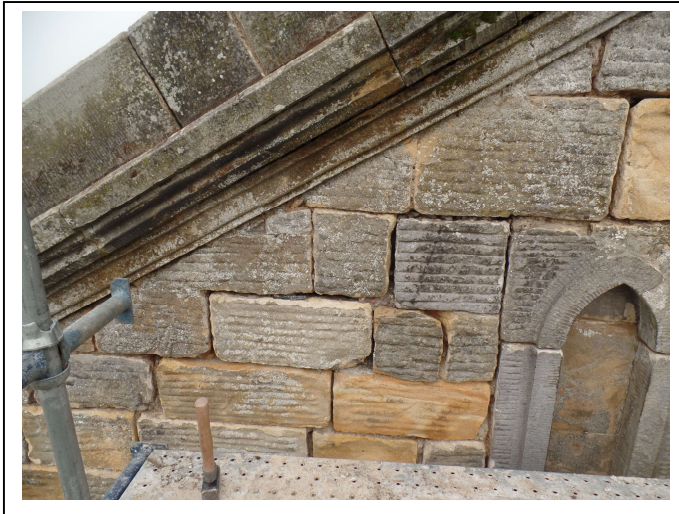
The East Gable wallhead after mortar excavation. It was very apparent that there was a much bigger problem with this wall, as the pointing on the Coursed Rubble stones appeared very much poorer than in other parts of the elevations.

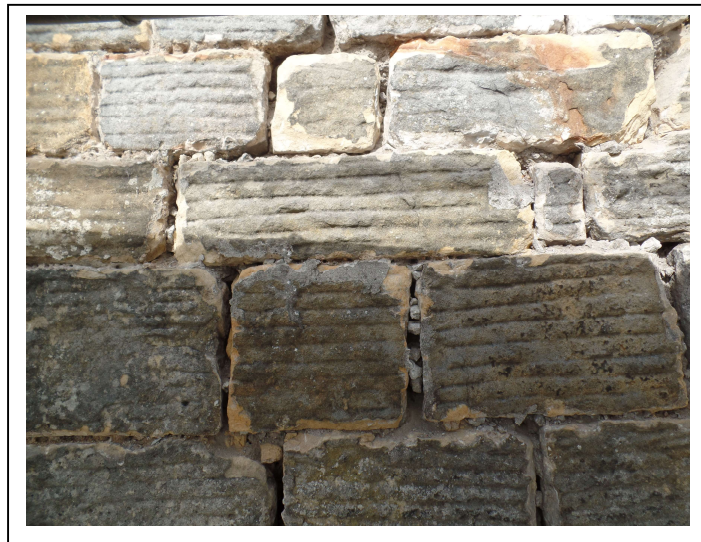
As the joints were opened up, it rapidly became apparent that there seemed to have been a much earlier campaign of work on the gable; but it had not been done well, as many stones were broken (causing vertical joint weakness) and were out of horizontal alignment.

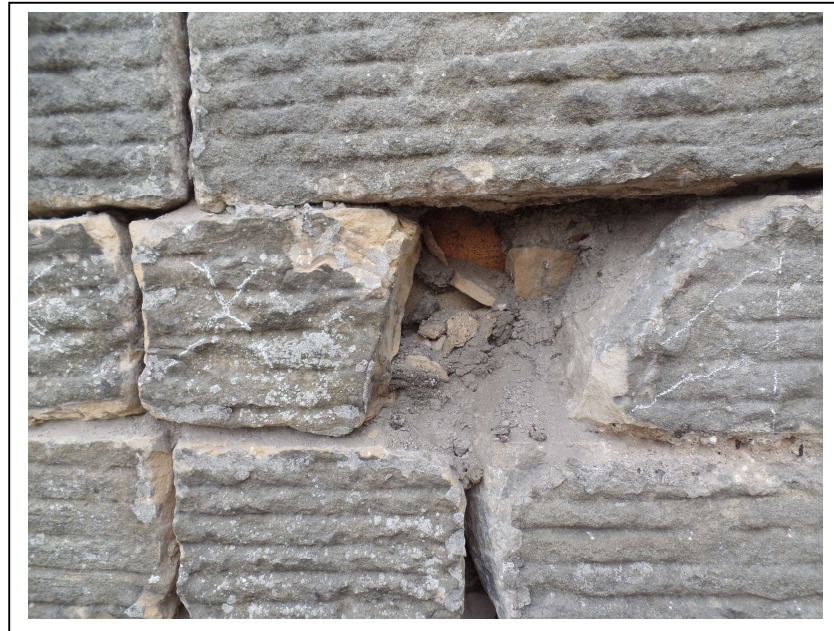
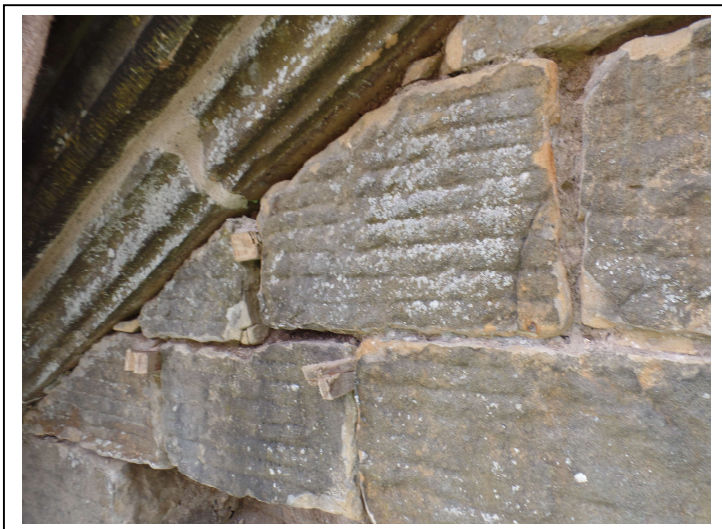
The culprit! Removal of a small broken piece of stone (it simply fell out!) reveals behind it a clay chimney liner. It was now apparent that, when the “Session Room” (as it was then) was built, a flue had been inserted into the wall from the fireplace, vertically up, then at an angle near the wall head, and up to a chimney head built behind the Cross.

However, it was also apparent that the clay pipes had been bedded in a CEMENT mortar (early examples of this had been in use in Scotland since the mid 1800s), and the removed stones had been replaced using the same material – but very poorly!. This mortar was now crumbling and had no structural integrity whatsoever.

To allow for removal of the stones over the flue, and to rebuild the wall, those stones

that were not to be removed had to be “pegged” to ensure that they did not slip. Wooden wedges were used for this purpose, and the wall then – carefully! – opened. Stones to be replaced had been measured and ordered from the quarry in Edinburgh.

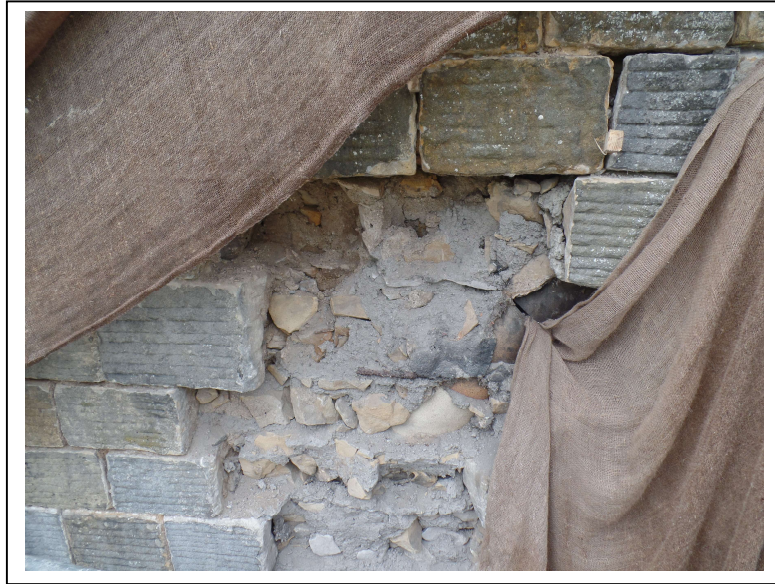
The full extent of the horror now revealed! The grey material is the (now useless) Portland Cement. The browner material at the top LH is the original 1815 lime mortar. The small stones are the “packing” stones used in the middle of the wall, behind the dressed stone on the outside and the internal lining stones. Examples of these can be seen on the internal walls of the Tower.

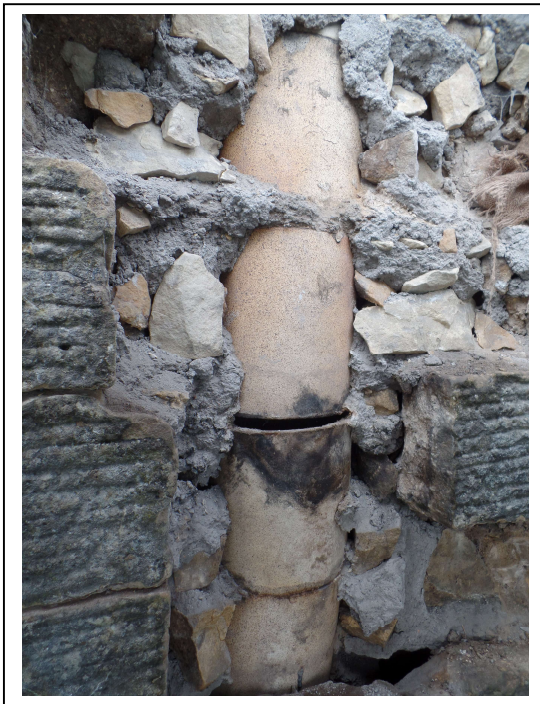
Very shoddy construction of the flue liner! The gaps would allow acidic gases from the coal fire in the Choir Room to penetrate into the wall structure, and then condense to form sulphuric acid, which would in turn hasten the degradation of the mortar packing.
