The Church of Scotland
BISHOPTON PARISH CHURCH
Erskine Ferry Road, Bishopton, PA7 5PP

Masonry Conservation Project Phase 3 - Final

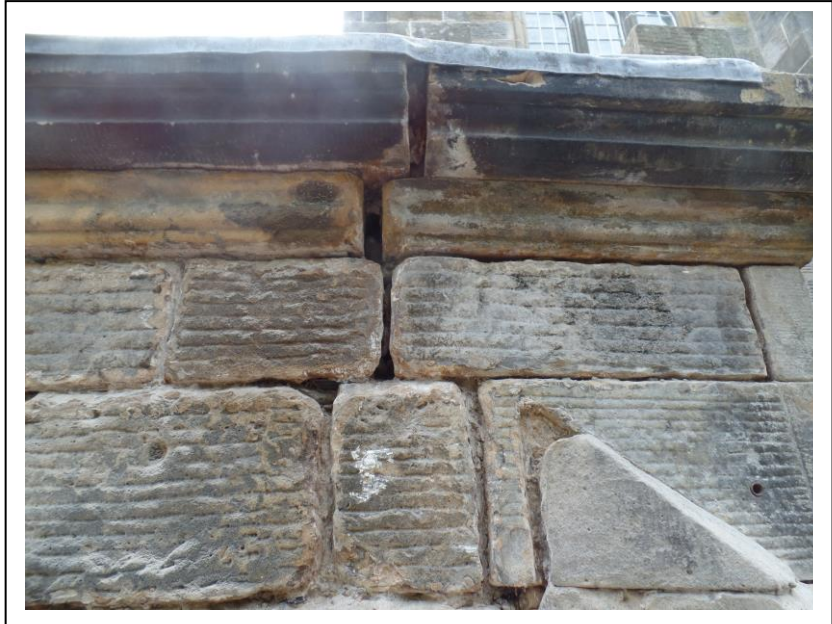
There was a concern that an old flue in the NW corner of the Sanctuary may have degraded in the same way as the flue on the East Gable. There was some evidence of disruption at the NW cope, and this photo after excavation shows a degree of movement.

The source of the flue was known and was explored. It had old twigs in it and led to the top of the wall, but no distinct exit point could be found and all the masonry appeared to be in fair condition.

No further work was required other than some re-setting of the copes above where the flue appears to have been run.

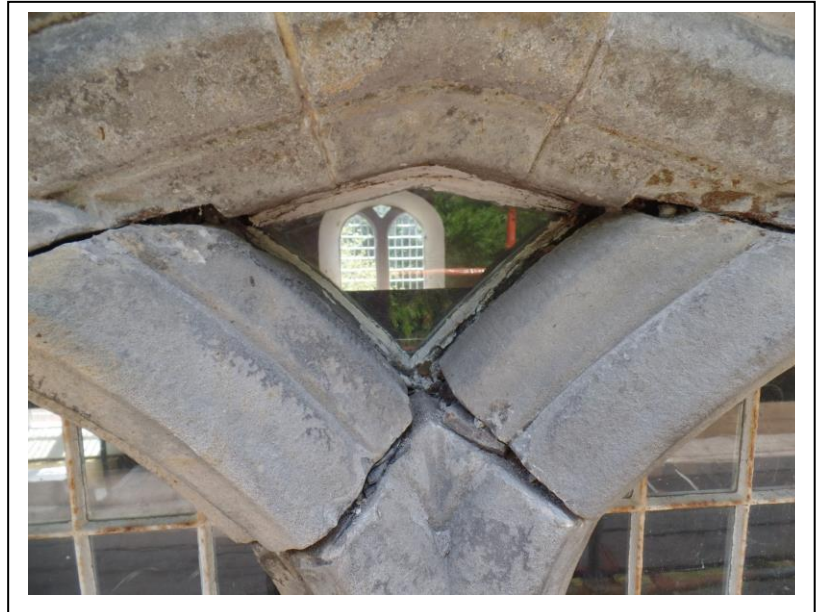
The windows were found to be in a similar condition to the other aspects of the building, as were the ashlar mortar infills around the detailing.

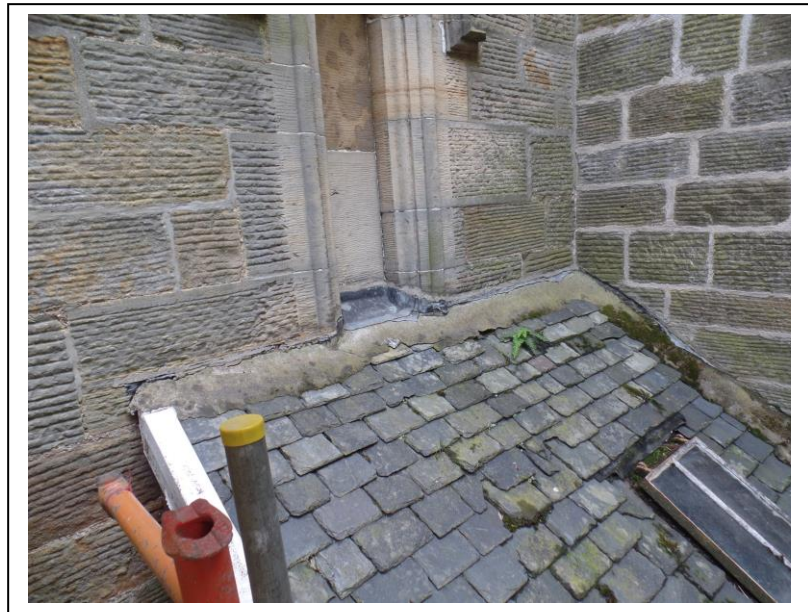
Before the final lift of the scaffold could be erected, it was found that the roof of the Plant Room (not part of the project) was found to be “spongy”. This entailed a re-think about how the final lift should be installed, and also raised concerns about the condition of the roof. The “dodgy” pointing around the top of the roof raises alarm bells!

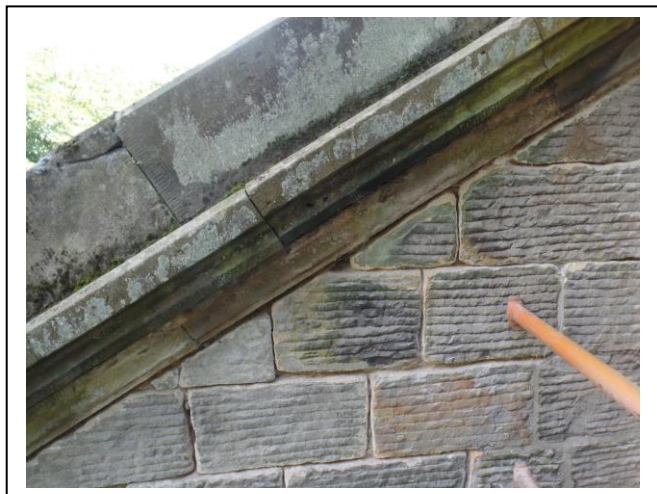
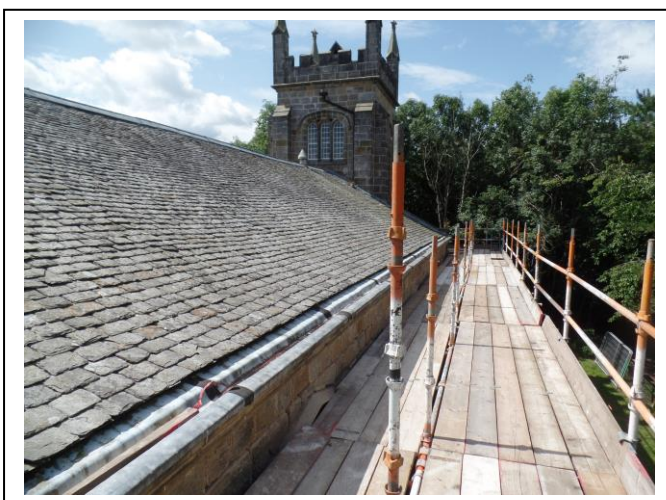
The West Gable Some loose-ish stone and copes, but no evidence of a flue exit, and no real evidence of movement.

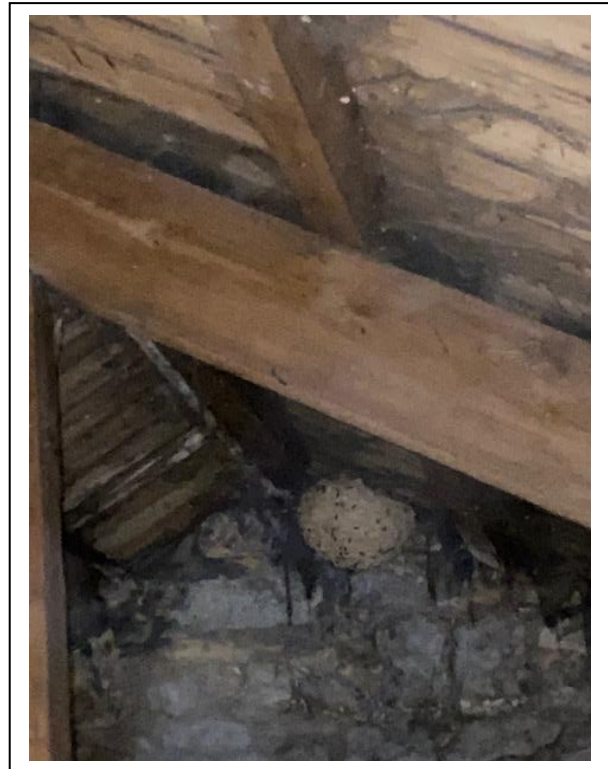
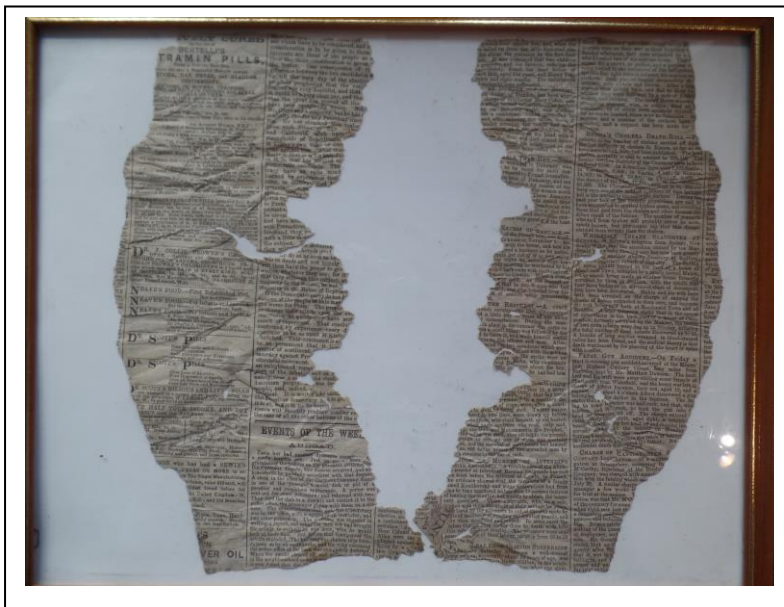
Project hazards – a wasp nest found in the loft space, with a very active colony entering and leaving through the slates at the East Gable. Fortunately, easily accessible from inside and rapidly dealt with!

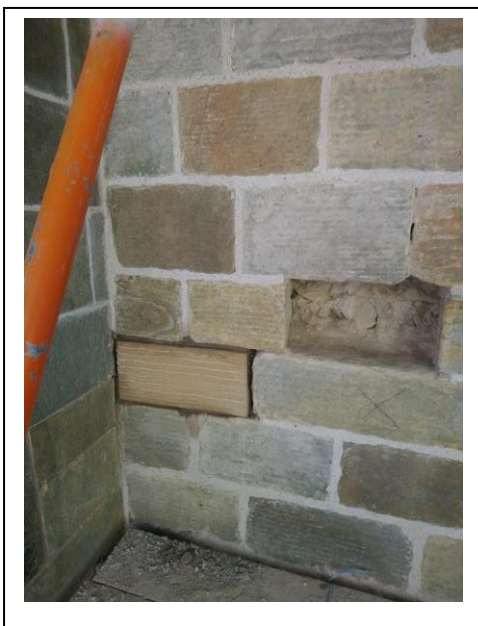
Adjacent to one of the buttresses-

a greater number of stones on this elevation (compared to the two earlier phases) seemed to need replacement. Reasons for this may be

- a) Being on the North elevation means that they are subject to damper conditions over the years (as evidenced by the algal growth) leading to earlier deterioration, or
- b) Being on the less-seen

aspect of the Church may have meant that the original quality of stone may have been poorer than on the more visible aspects of the building. This is partly supported by some of the work done under the windows – although this in turn may have been from the possibility that additional work on the windows was required in the early 1900s.

Stone replacements going in:-

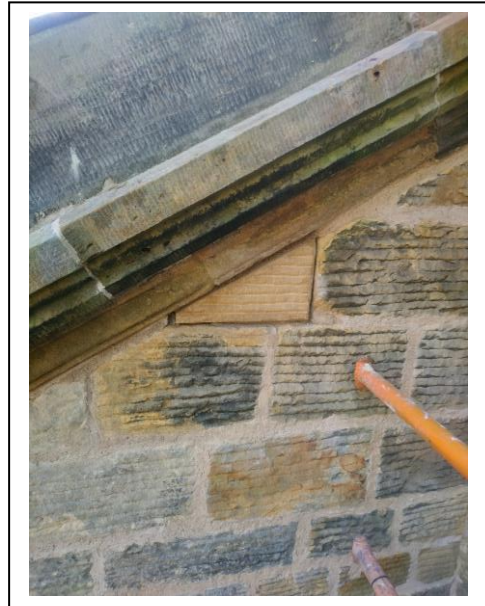
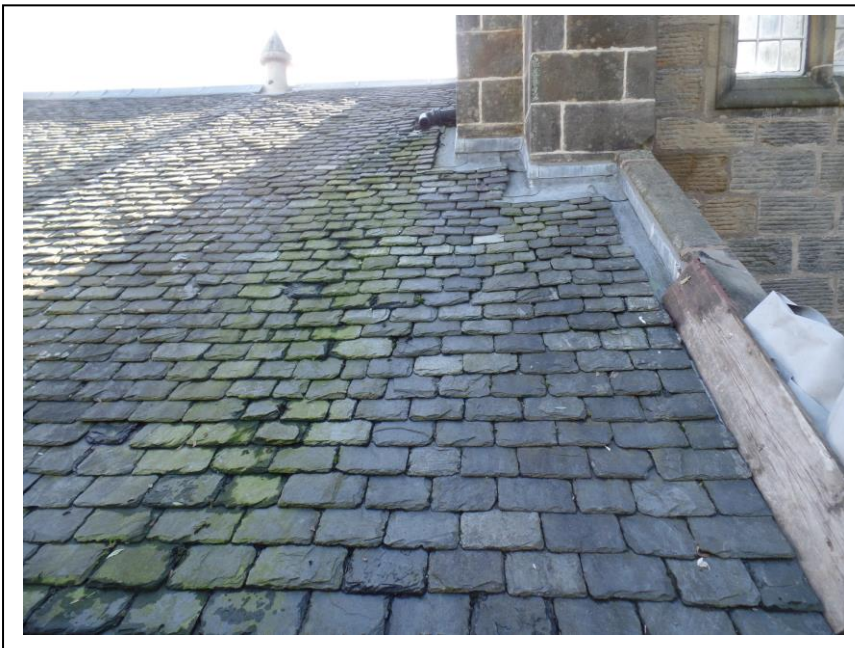
At the roofline.

Note matching colouring in the new stone with the old stone. Although the new stone comes from a quarry near Edinburgh, it is thought that this is actually the same stone stratum as in the original quarry in Renfrewshire. This could possibly be confirmed by comparing the chemical and structural compositions from the two stones.

The replacement stones have also been “tooled” (the horizontal lines carved into the surface) to match the original stone finishing.

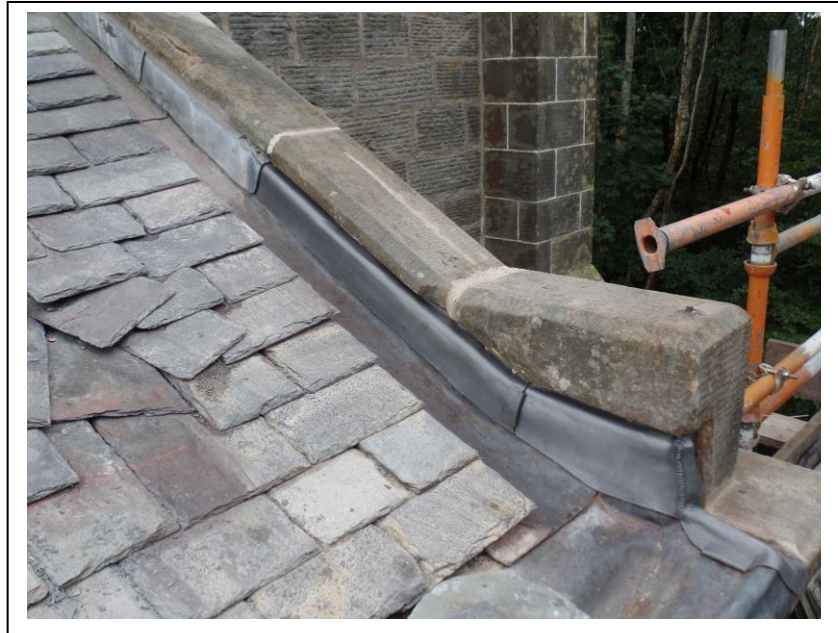
Roof works are about to commence. The main area of concern is at the west end of the roof where rainwater coming from the tower has been directed to run down the slates, increasing their exposure to prolonged dampness and Verdigris growth.

There is also concern about the capability of the lead margins to carry away rainwater – especially as climate change means that rainfall is heavier – with the result that rainwater may

over-top the flashings and get underneath the slates. Almost all of the area shown required stripping, investigation and timber repairs before improving the lead flashings.

The slates have all been reset and the lead flashings improved to give a better rainwater capacity.

In addition, the rainwater-goods arrangement from the tower has been modified so that the water is no longer directed onto the slates, but instead is directed onto the lead flashings, where the water flow will help to flush away leaf debris before it can settle.

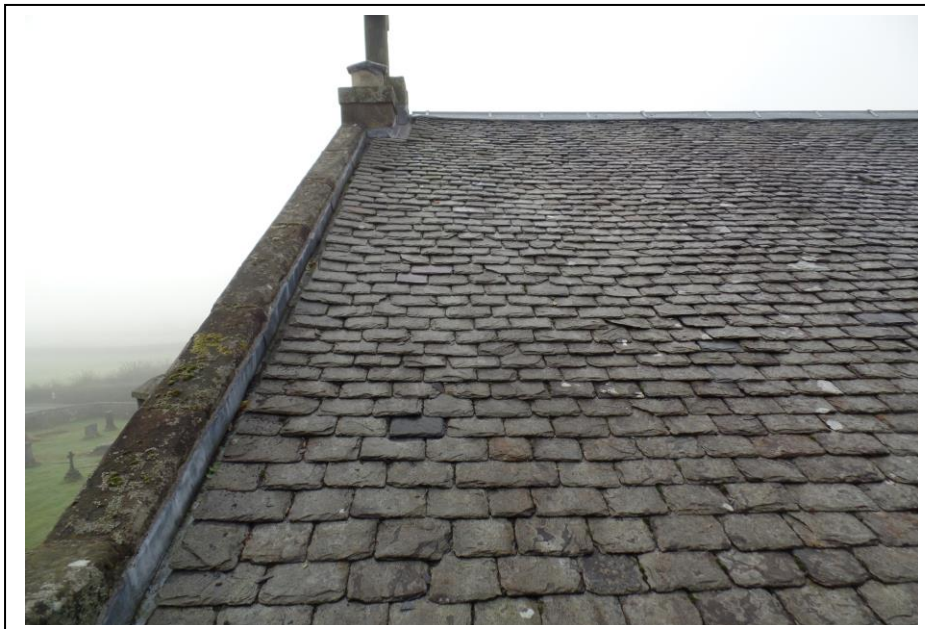
The rest of the roof was checked for loose slates and other potential problems. Most were found to be in good condition but some were crumbling and had to be replaced

The attraction of the pipe as a nesting site has also been removed!

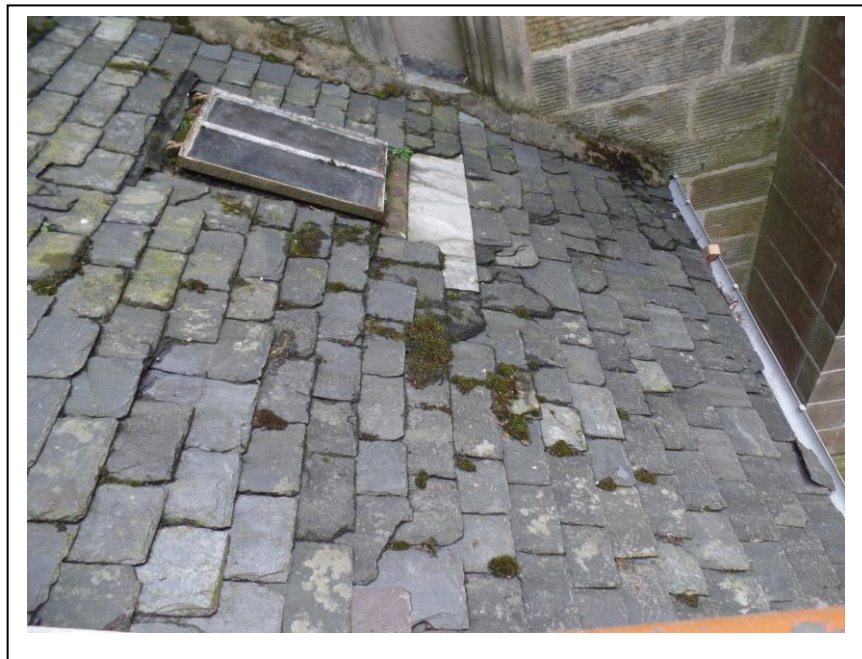
The Plant Room roof. This was not part of the specification, but was found to be in very poor condition, so it was agreed to undertake necessary repairs – essentially, re-roofing involving removal of all the slates and the skylight, repair of timbers, then re-slatting and replacement of the cement flashings with properly crafted lead flashings.

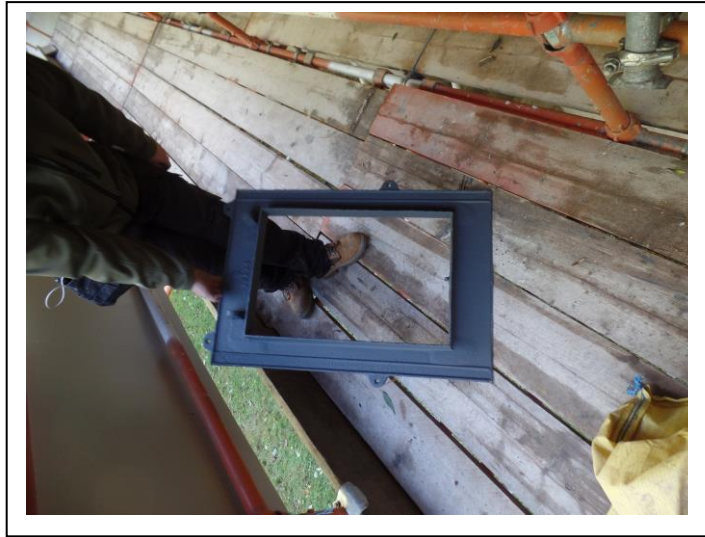
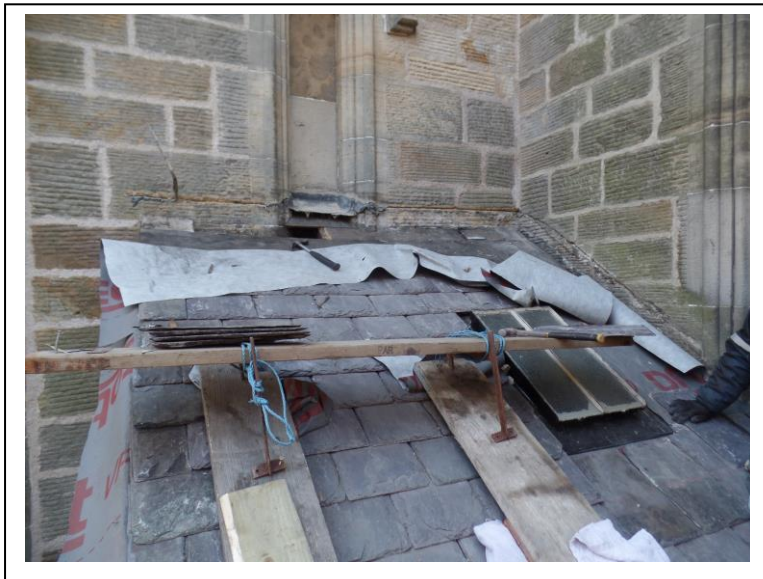
The salvaged skylight (cast iron) was found in good condition once cleaned up and was re-used.

Repairs well under way. The timber “wall head” at the brick wall has been replaced and about a third of the roof sarking boards renewed.

The skylight has been replaced and slating is mostly finished and awaits only the lead flashings going in.
