The Church of Scotland  
**BISHOPTON PARISH CHURCH**  
Erskine Ferry Road, Bishopton, PA7 5PP

## **Masonry Conservation Project Phase 2**

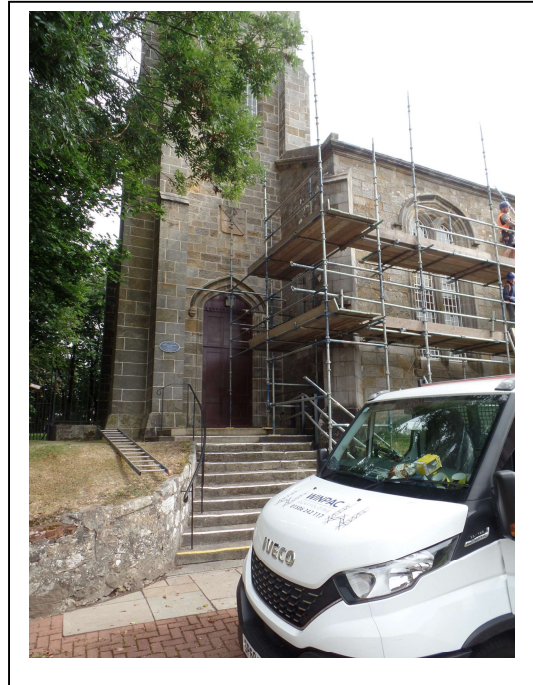
The scaffold going up – day 1. The arrangement unfortunately means the stairlift cannot be used.

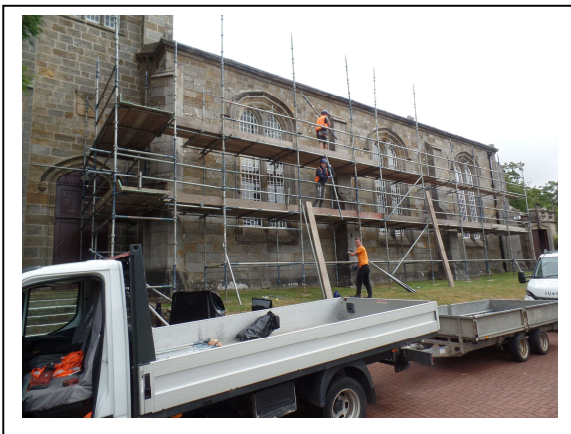
Scaffold fully erected – day 2. This clever arrangement leaves the Choir Room steps and door clear and minimises loading on the Choir Room roof.

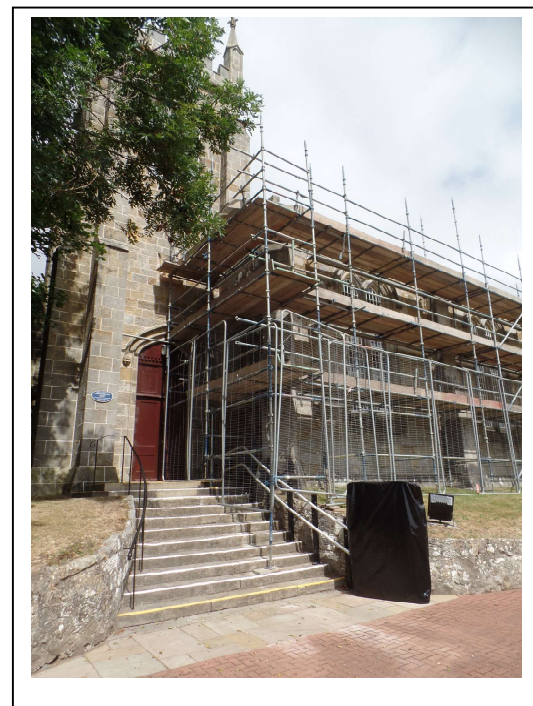
The finished scaffold, now with ant-climb measures and weather protection. Work has started on the top lift.

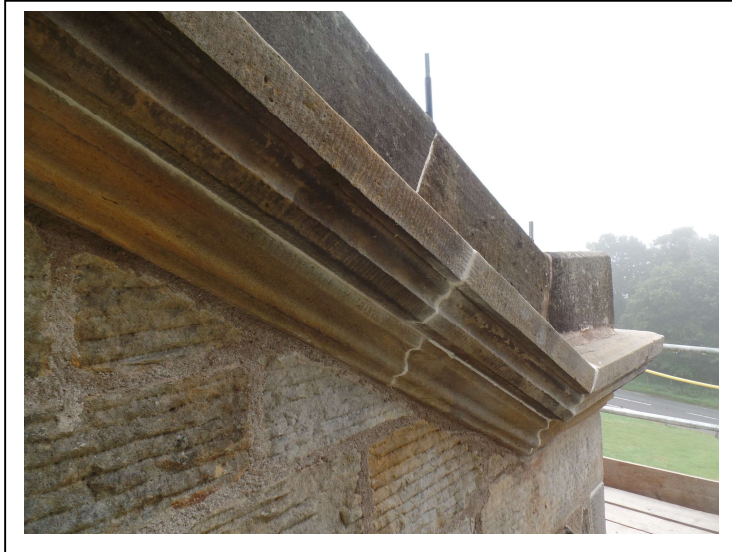
The West gable, both coursed rubble and Ashlar have been pointed. The visible mortar looks darker than that on the Tower (from 2018), but has still to dry fully. ALL the West, South and East elevations have been steam cleaned to remove algae and lichen from the surfaces.

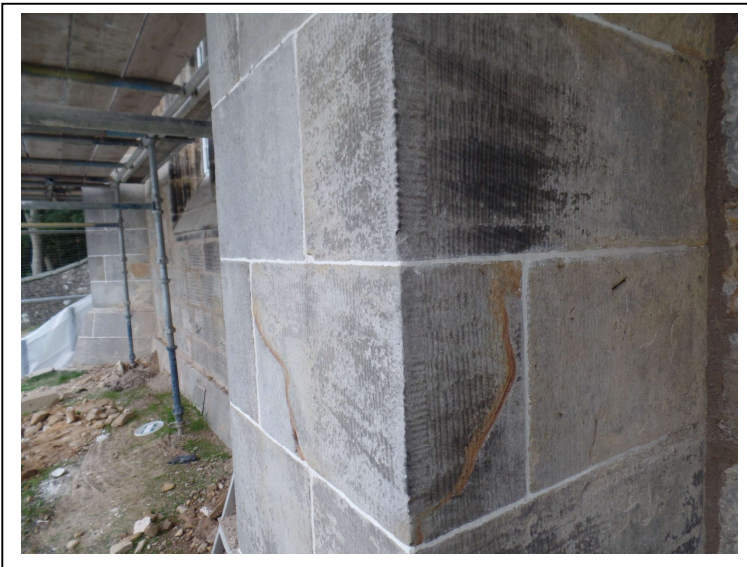
South elevation buttress at ground level. These have been “tooled” lightly using vertical tool marks. The Coursed Rubble stones by contrast have horizontal and deeper tooling marks. Note the coloured veins in the stone.

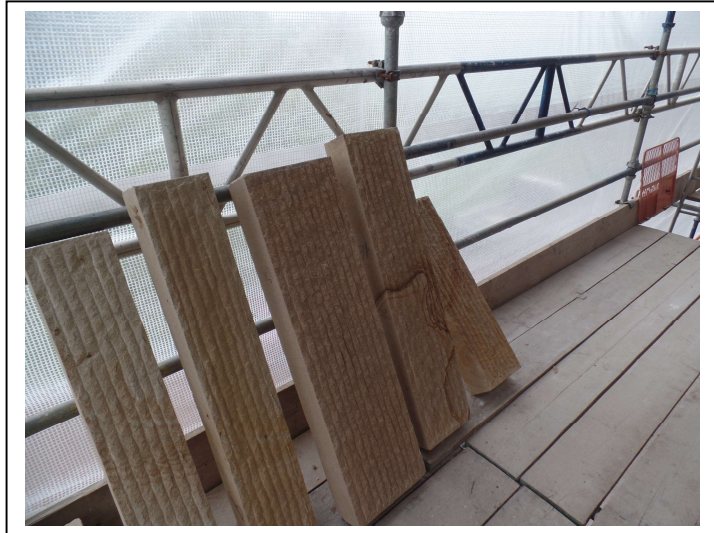
New stones for the East Gable. These are machine cut and the tooling marks on the front have been made by the Limerich stonemasons. The original stones would have to have been fully hand-formed!

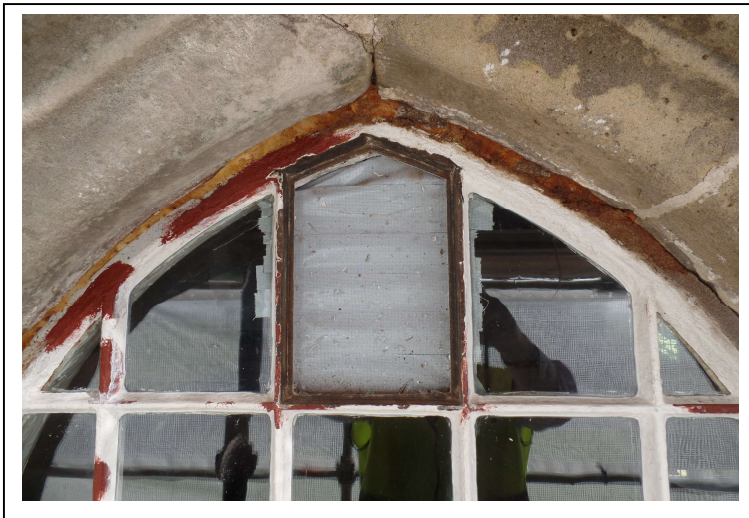
The windows have been scraped to remove loose paint and putty. Red primer has been applied to the bare metal to seal it before new putty is applied. The pointed pane at the top was cracked and has been removed to allow replacement with a new pane. For authenticity, the new glass is from stocks of traditionally made glass.

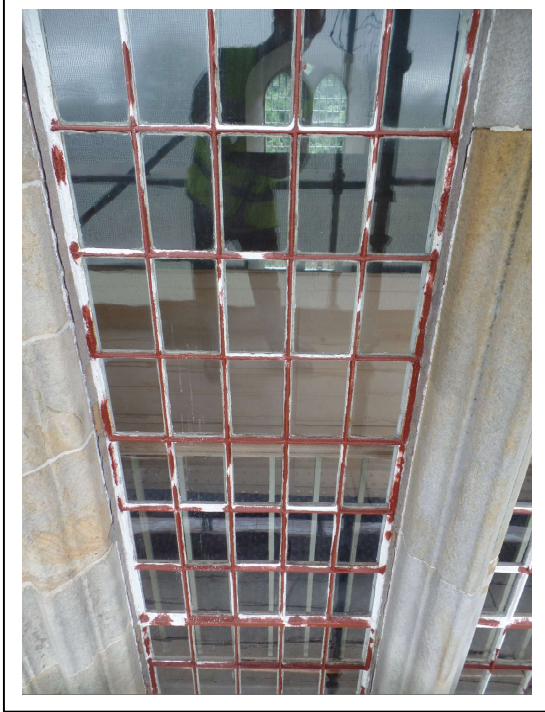
One of the tall windows on the South elevation. These are cast iron. Although cast in at least 2 sections (some were able to be opened), the skill needed to cast these in 1815 must have been immense – it probably couldn't be done today using the facilities available in 1815!

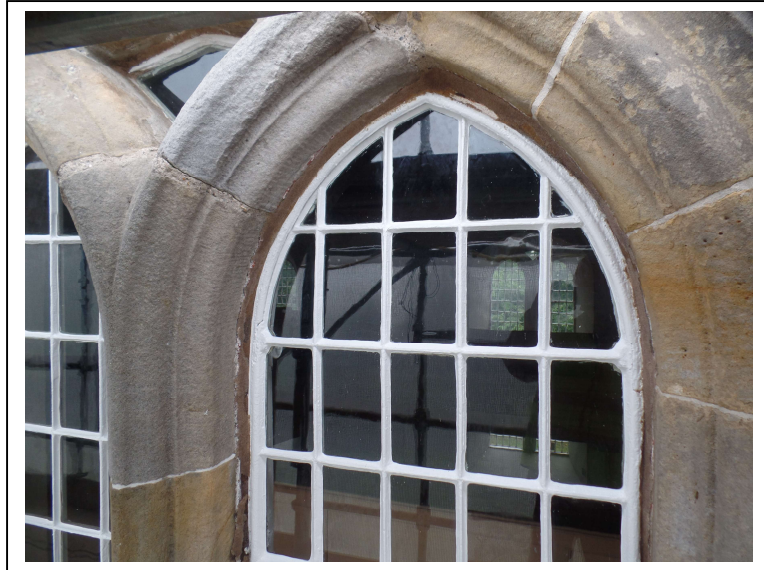
One of the East Gable windows. These were found to be in reasonable condition. There is however a need to properly repair one of the windows where the timber cill had failed and was letting rainwater into the Extension Hall. A temporary repair had already been made, so this work has been deferred until the final Phase of works, as it can be accessed comparatively easily from the Choir Room and Extension Hall roof.

Some works have had to be carried over to Phase 3. We could not manage to get a good lead worker in time to attend to the roof flashings, and it was decided to leave work on the East Gable windows to the next phase. Neither of these are urgent and will wait without causing any significant problems – but we know they are there and need seen to.

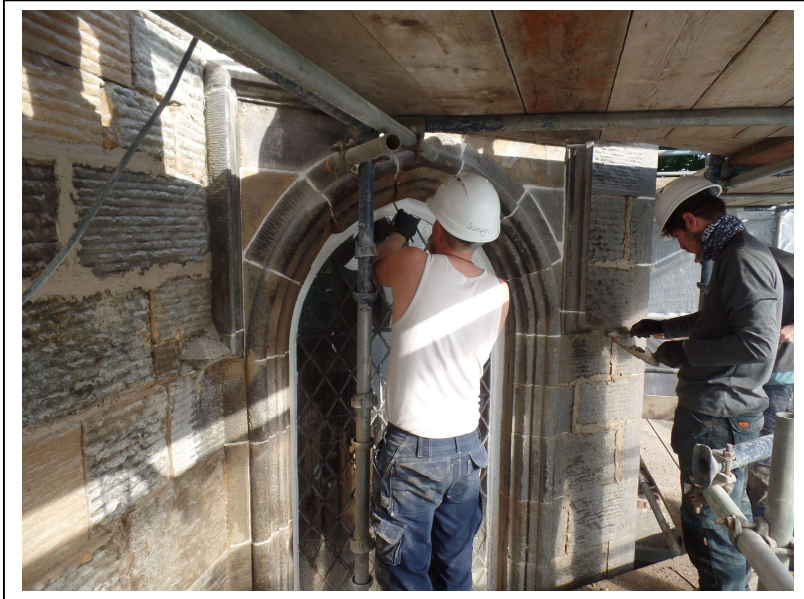
Finishing off the East Gable. This work had been left until the repairs to the wall had been completed. The use of the syringe to inject the white mortar into the Ashlar joints can be seen. Still good weather!

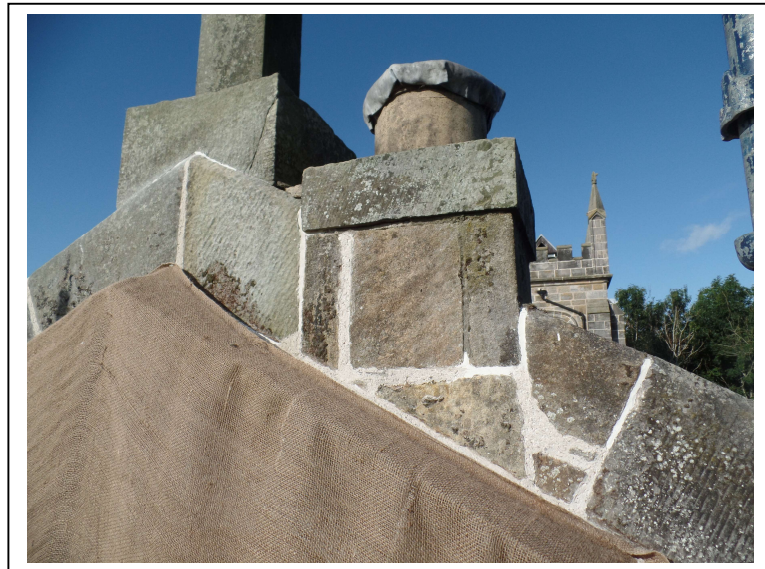
The finished chimney head. Again, note the hessian to protect the drying mortar in the Coursed Rubble stones.

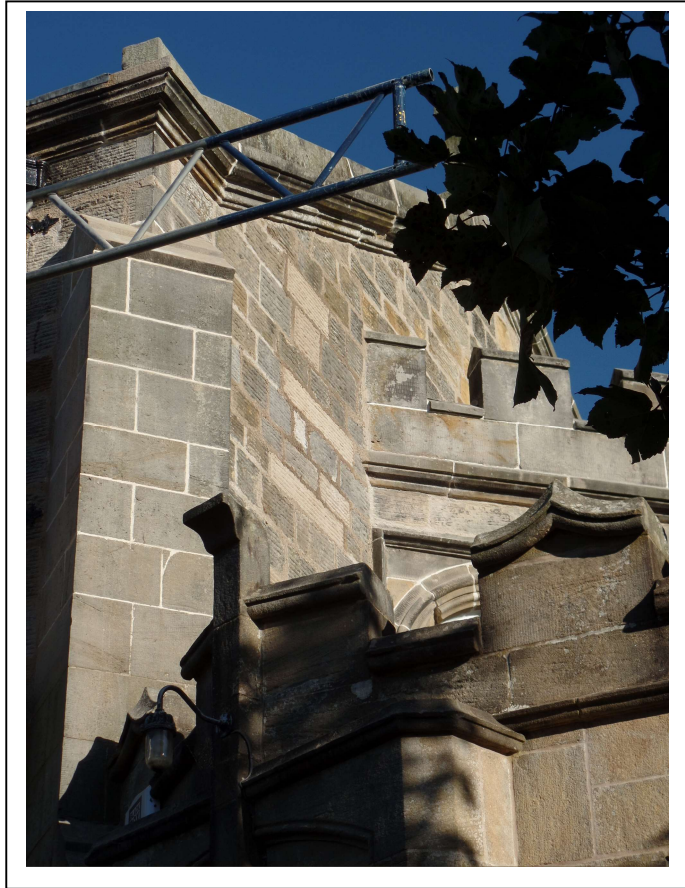
The finished Gable. The scaffold is coming down with all repairs complete.

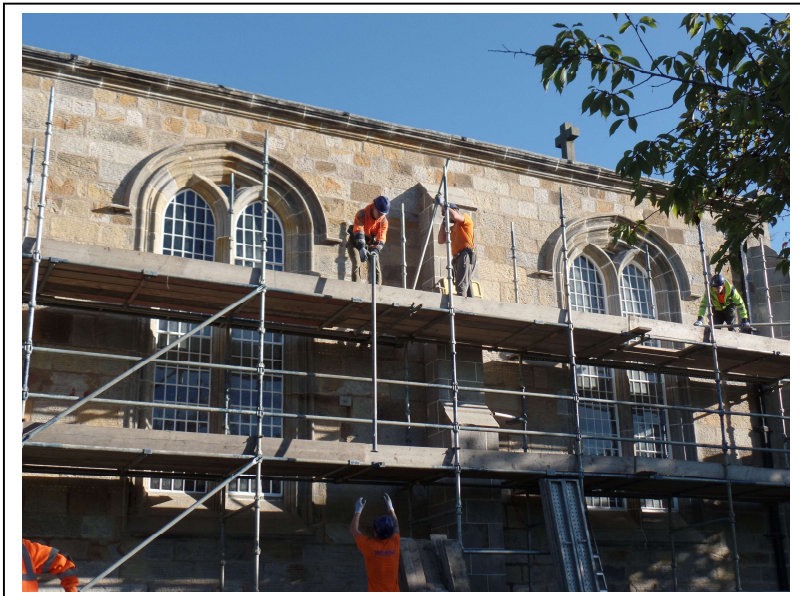
The scaffold coming down. 2 days work, and the finished work is revealed!

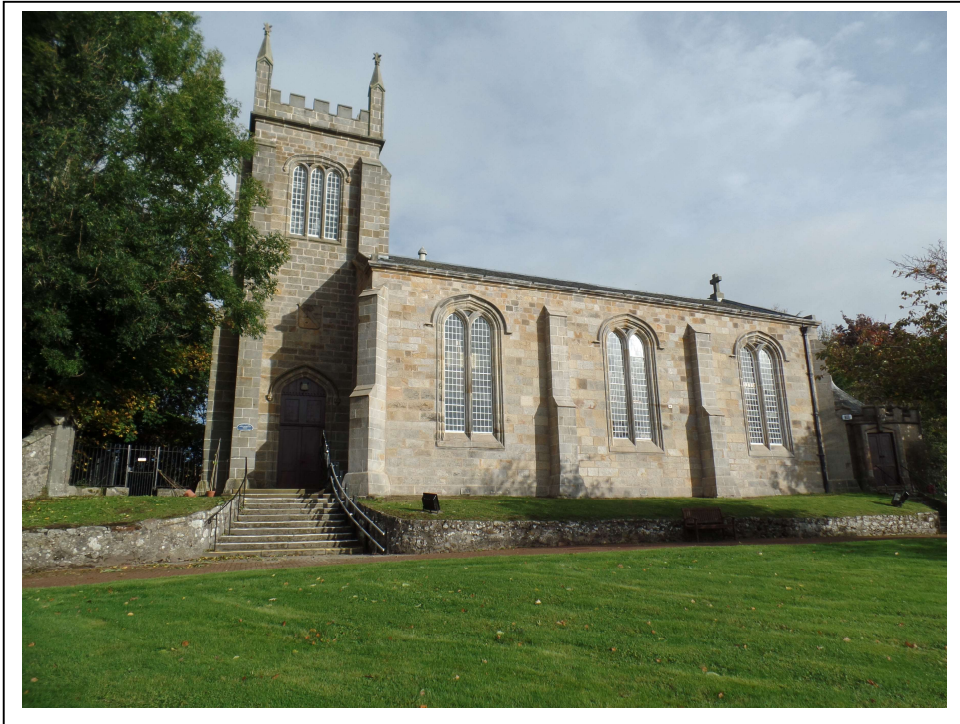
All tidied up,  
stairlift back  
in use. The  
grass,  
though a bit  
sorry for  
itself, will  
recover!
